VEHICLE FIRES

A PRACTICAL APPROACH

by
Mike Higgins - K-Chem Labs - Westford, Massachusetts

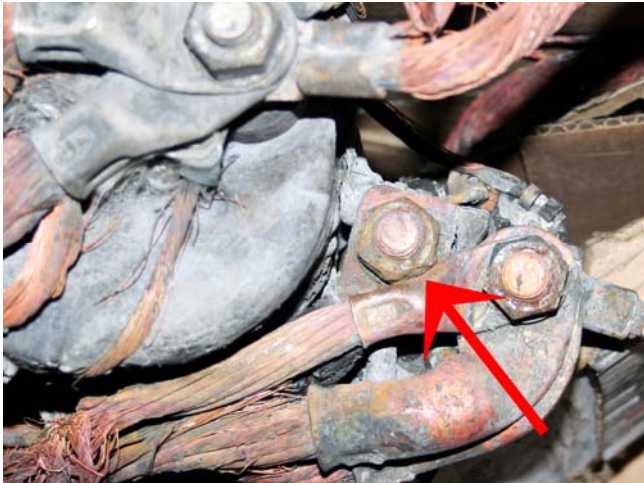
Improperly factory installed battery cable on the solenoid caused five new vehicles to burn.

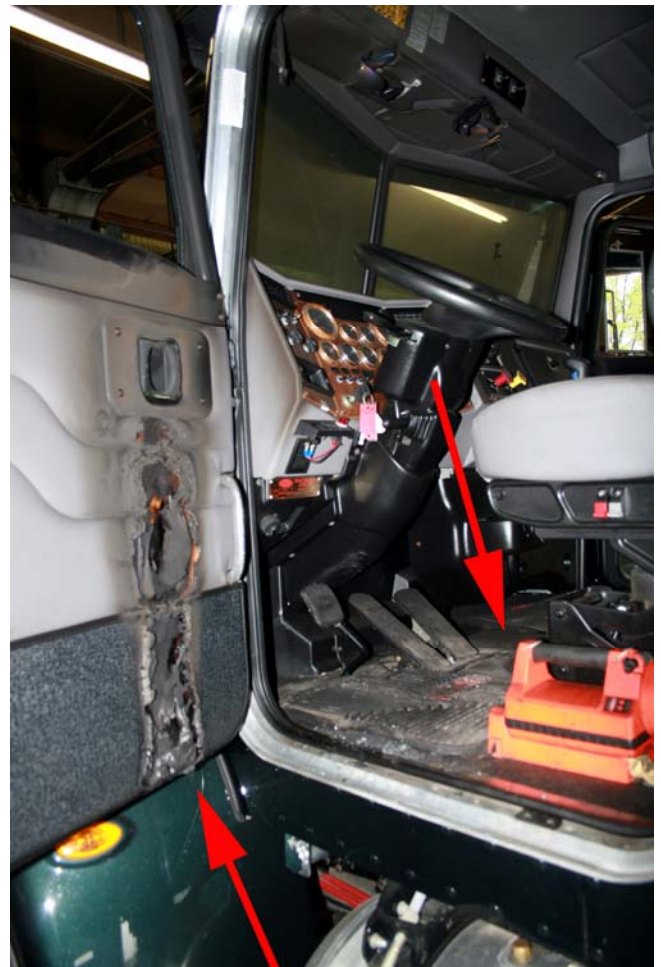
Fire along the door of this vehicle was caused by poor workmanship while installing a 12volt line to a lantern charger

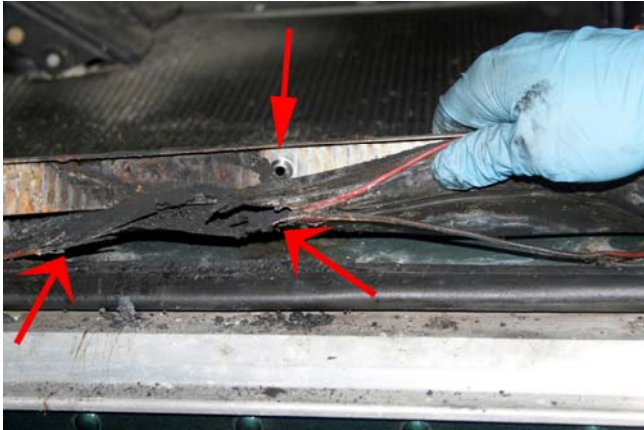
Wire were installed under metal trim and hold-down screw penetrated wire insulation causing short to ground

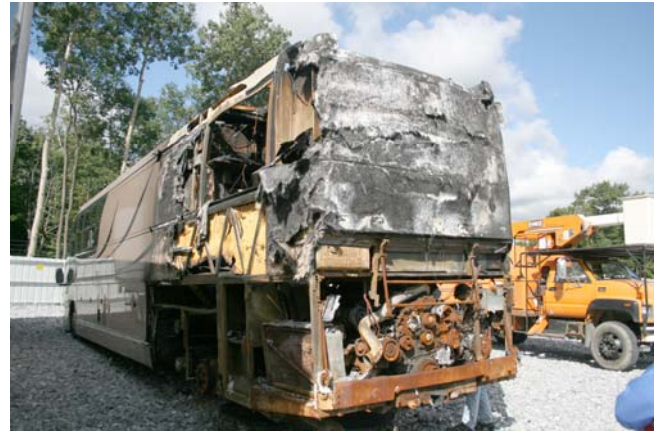
This personal bus stated burning at rear left side while driving

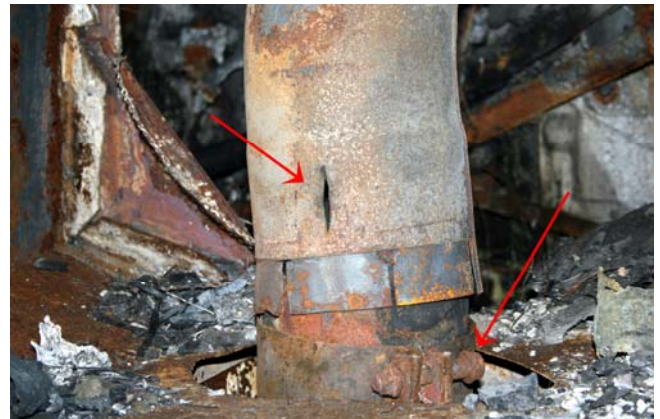
Poor maintenance failed to properly tighten engine pipe exhaust clamp was the cause

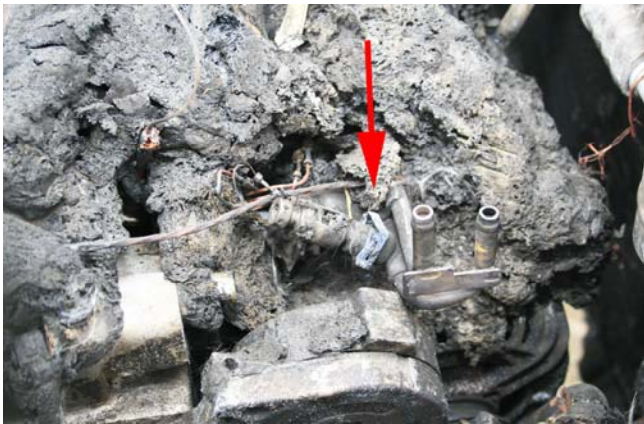
Improperly installed fuel injector destroyed this vehicle

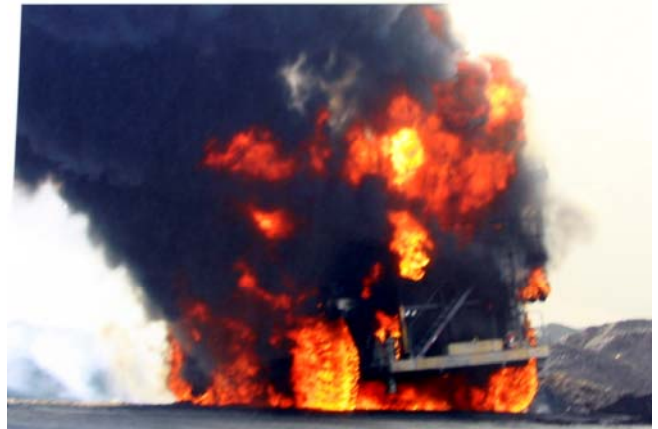
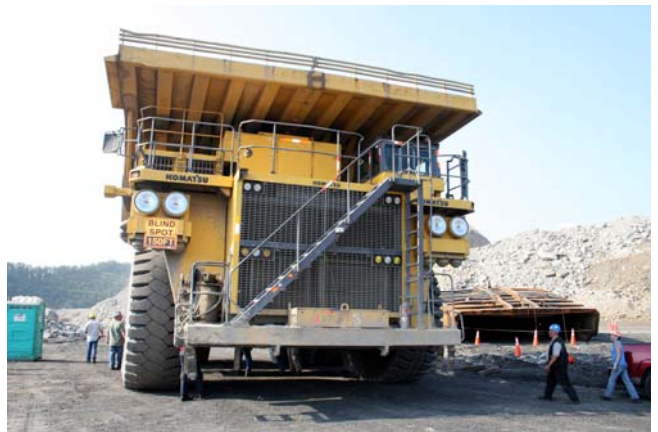
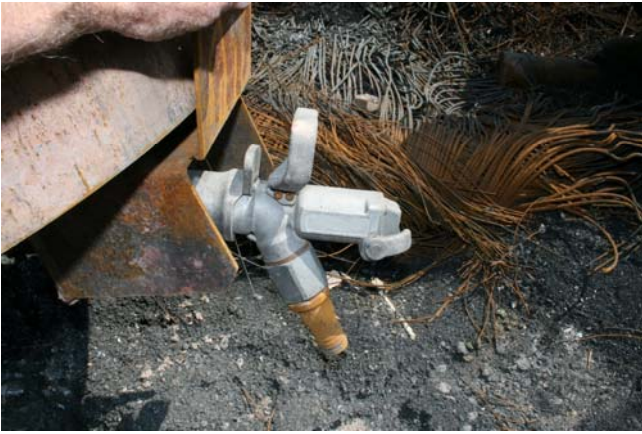
The above vehicle was totally destroyed as a result of a defective auto shutoff filler valve causing diesel to over fill the tank and the vehicle left running while being fueled

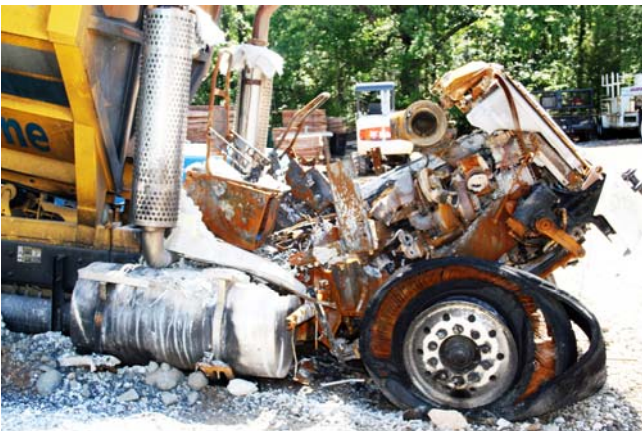
This truck burned while idling

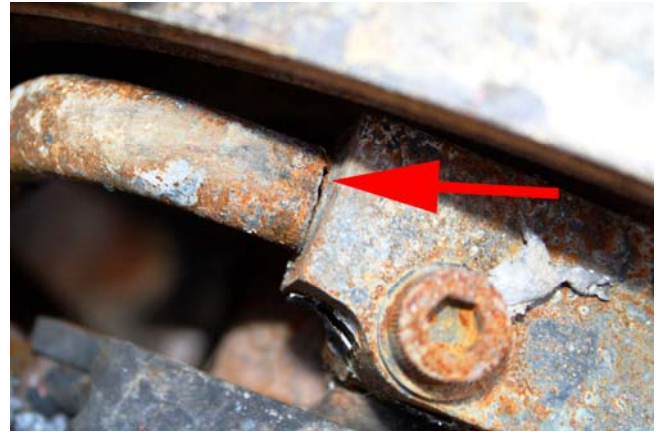
A cracked oil feed line to turbo was the cause

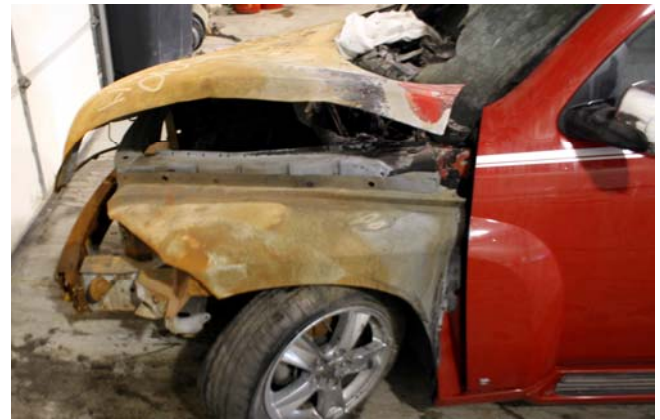
Fire started in front of the vehicle after it was turned off

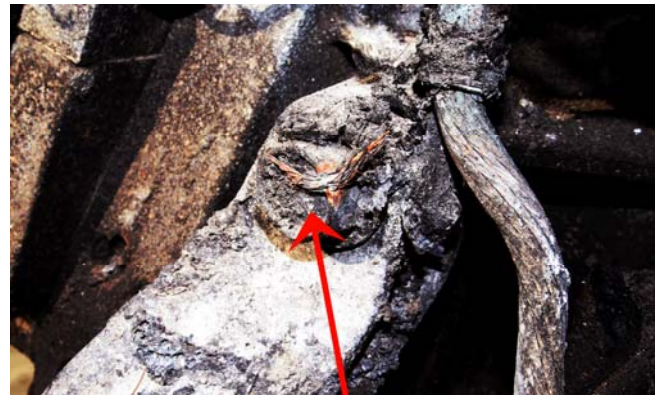
Defective cooling fan caused the above fire

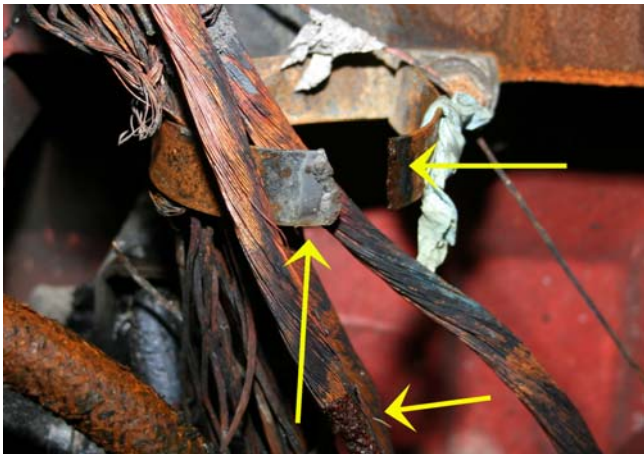
A loose battery cable clamp wore through the insulation causing short. Note; cable never severed!

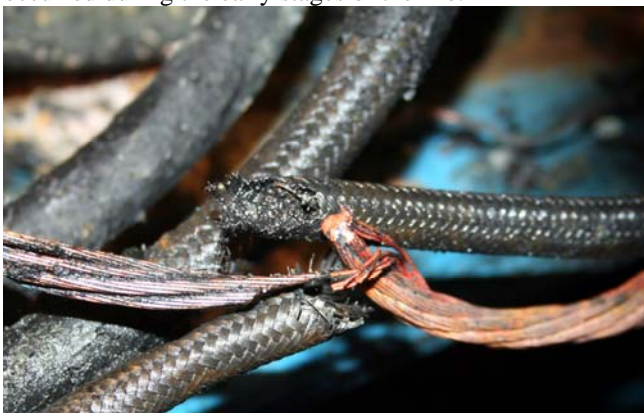
Poorly secured battery cable and fuel lines eventually wore through causing short circuit and fire
